**CONDITION AND VALUATION SURVEY**  
**40' PUGET TRAWLER "GLORIA J"**

DATE: 8/30/2007

REPORT NO: #1505

TYPE OF SURVEY: Insurance survey DATE OF SURVEY: Thursday, August 30, 2007

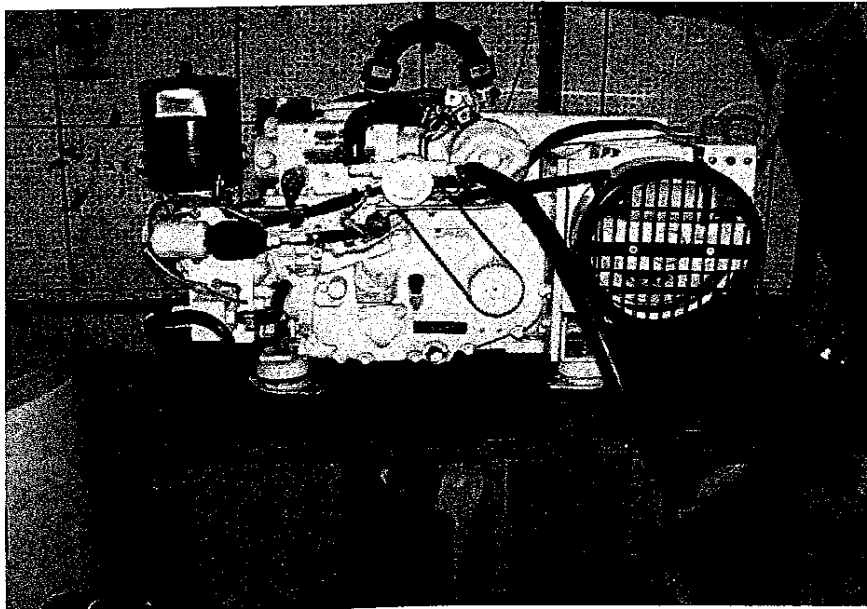
The diesel generator.

- 5) Found - The generator exhaust is only single clamped.  
Recommend - Investigate further, and double clamp all exhaust connections.
- 6) Found - The AC main breaker is a single pole type main breaker.  
Recommend - Comply to ABYC standards and install a double pole AC main breaker.

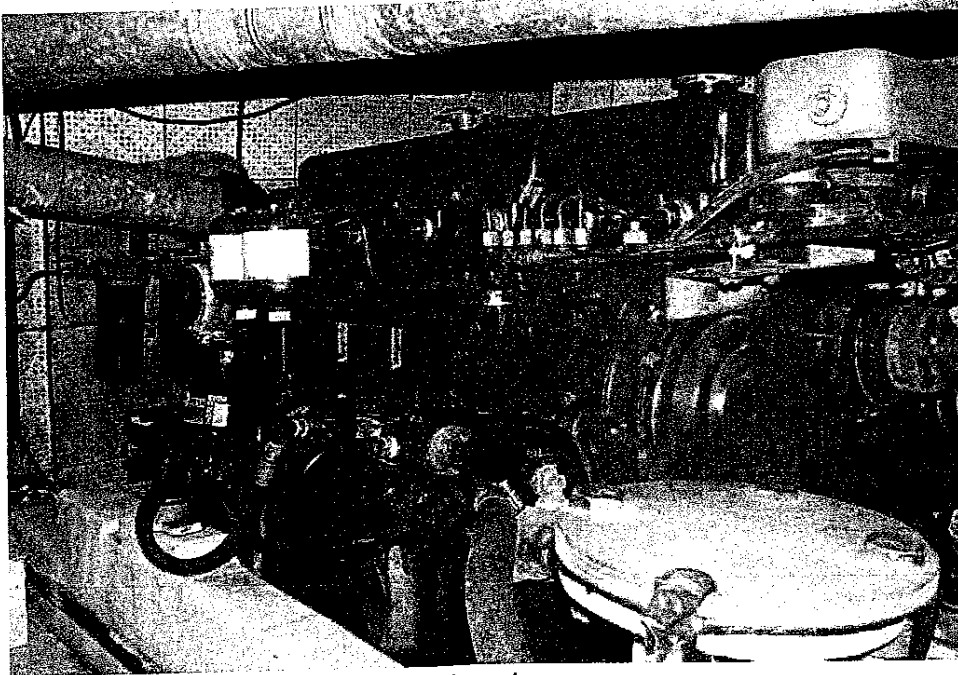
**The port main engine.**

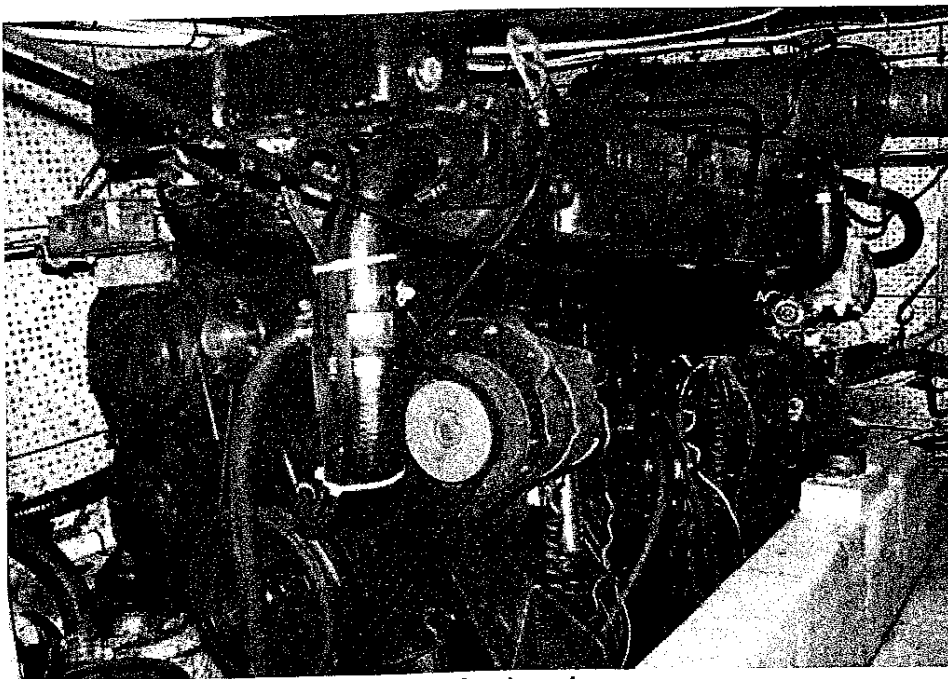
**The starboard main engine.**

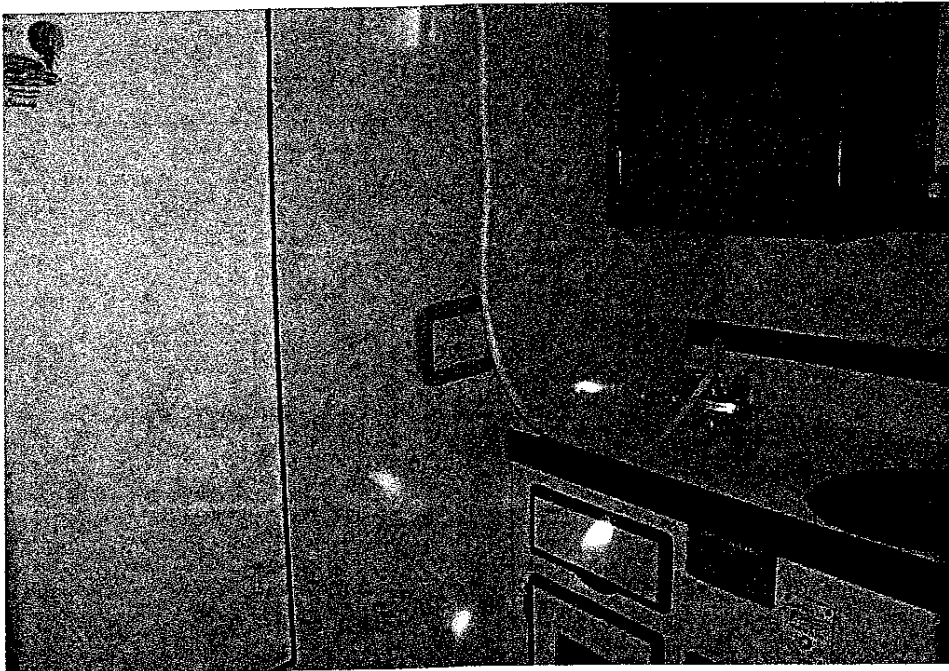
**The forward head.**

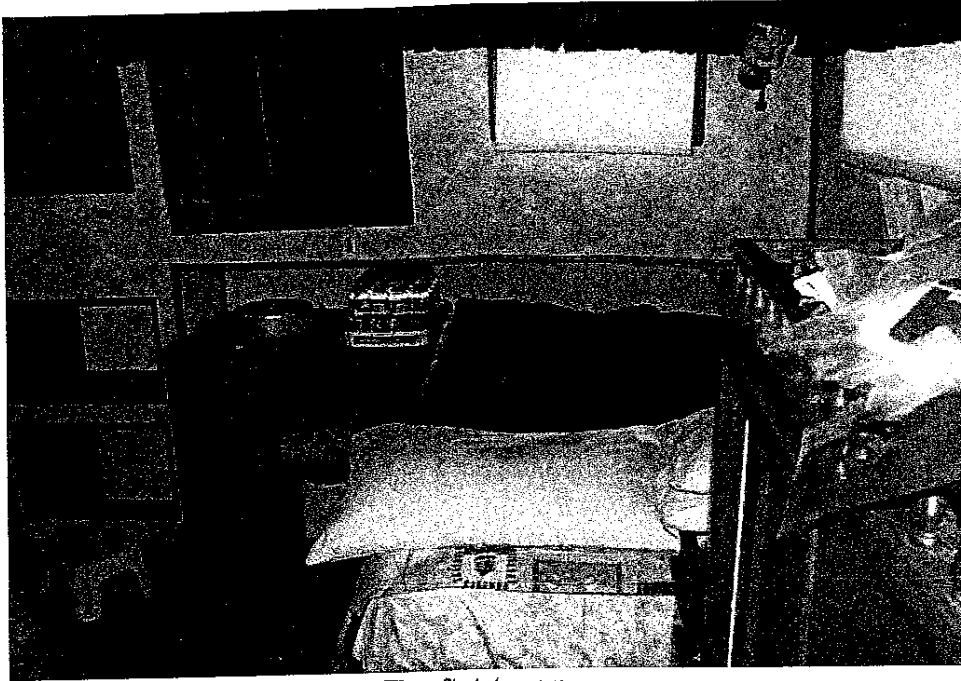
**The aft stateroom.**

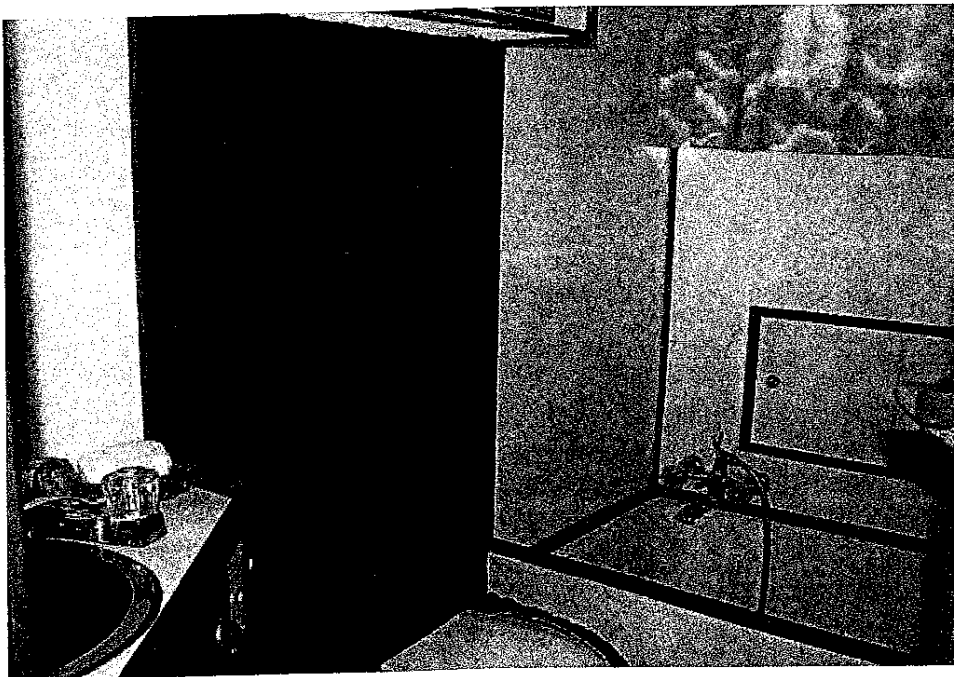
**The aft head.**
